TECHNICAL REPORT ARCCB-TR-92033

**FAILURE ANALYSES OF  
M3A1 BASEPLATE FOR 81-MM MORTAR 252**

STEVE TAUSCHER

JULY 1992

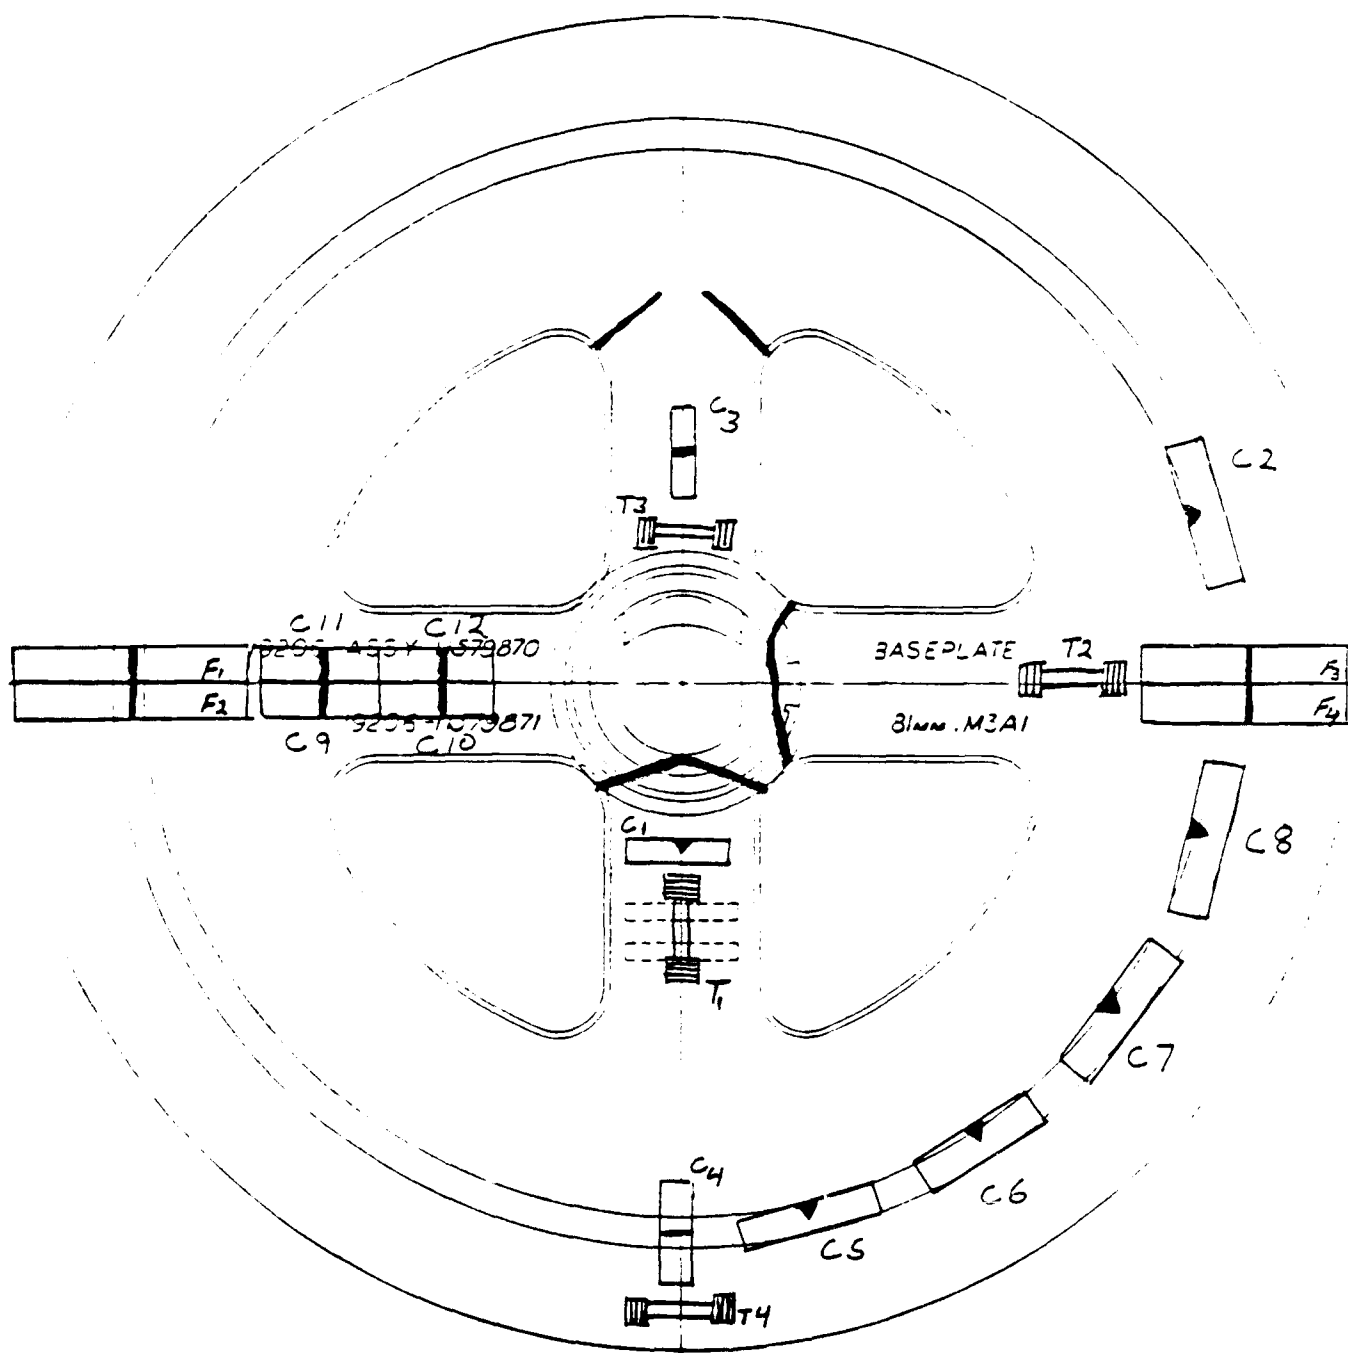
Mechanical property testing was conducted to verify that the baseplate met the requirements of Specification QQ-A-367H and that low mechanical properties did not contribute to the failure. Hardness, tensile, Charpy impact toughness, and fracture toughness specimens were taken from the baseplate at the locations and orientations shown in Figure 20. The grain flow pattern, as revealed by metallography, was used to sample for tensile properties parallel and perpendicular to the grain flow as specified in paragraph 4.2.3.1 of QQ-A-367H. Tensile, Charpy impact, and fracture toughness tests were conducted according to ASTM Methods E-8, E-23, and E-399, respectively. The properties are summarized in Table III and are representative of the fine-grained microstructures revealed through metallography. In all cases, the properties exceeded specified properties. Fracture toughness in this baseplate, which is not specified, was typical of that in 2014-T6 aluminum (ref 4). In summary, the mechanical properties in this baseplate are indicative of 2014-T6 alloy that has been properly melted and processed.

Figure 20. Schematic of mechanical property specimen section.
